# Sanitation

## The crusade for sufficient school sanitation

*A current Water Research Commission (WRC) study is exploring the status of sanitation in rural schools, and reviews best practice for infrastructure design.*

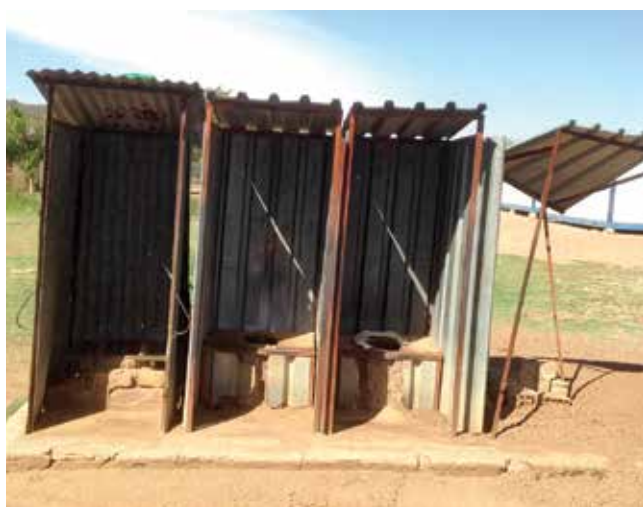
*Toilets with missing doors offer learners no privacy when using the toilet.*

The case studies document toilets that looked like they had never been cleaned, toilet stalls with no doors, full pit latrines and schools with no hand-washing facilities. In one example, the superstructure around the boys' latrines had been destroyed in a storm. In another, a primary school with 520 learners, there were only two pit latrines for girls and two for boys, giving a ratio of 1 toilet to 130 learners. Recommendations for the number of children to be served per toilet typically range from 1:20 to 1:50. According to the norms and standards, a school of this size should have eight toilets for girls and four toilets plus four urinals for boys.

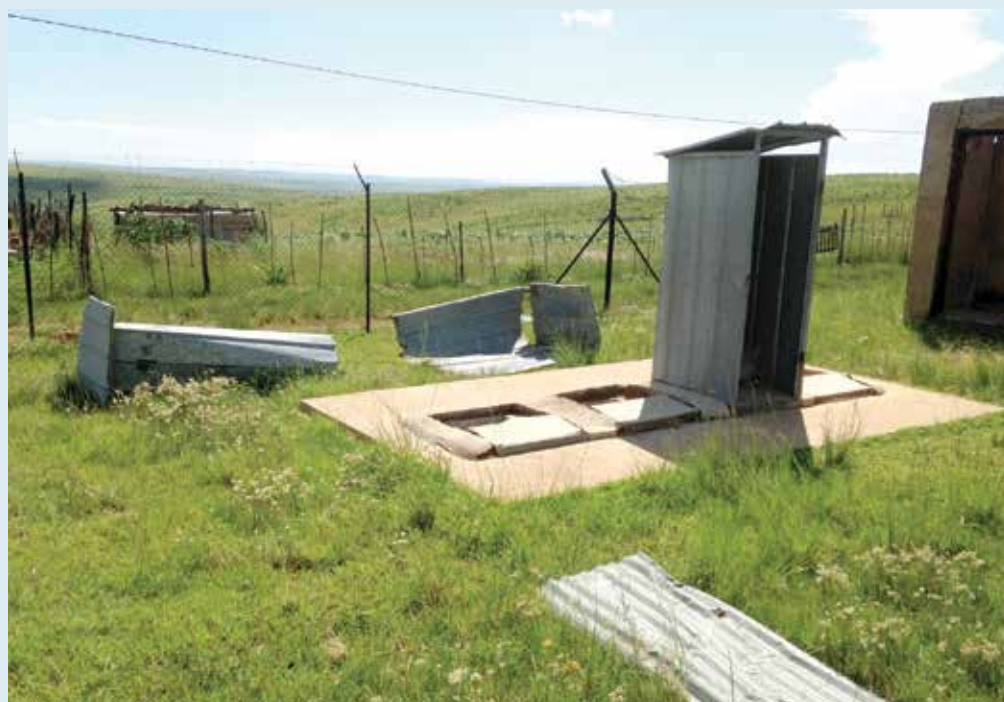
*Adequate construction and maintenance of toilet facilities is a significant issue at many schools.*

Indeed, follow-up visits to schools provided with new toilet blocks frequently reveal that their condition has reverted to a state little better than before. This is sometimes due to shoddy workmanship, leading the Auditor-General to recommend in the education sector report released in August that provincial education departments cease appointing contractors that don’t meet the Construction Industry Development Board’s requirements. But – as highlighted by the WRC report – it’s also caused by user behaviour, which has an enormous impact on the wear and tear of facilities and their cleanliness, as well as deliberate acts of vandalism and inadequate maintenance.

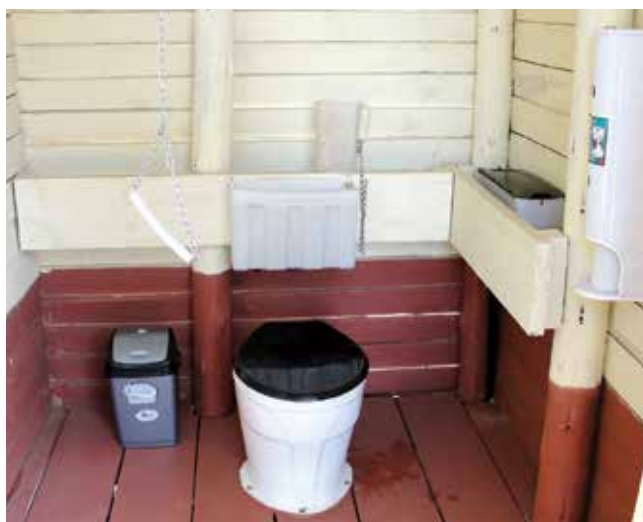
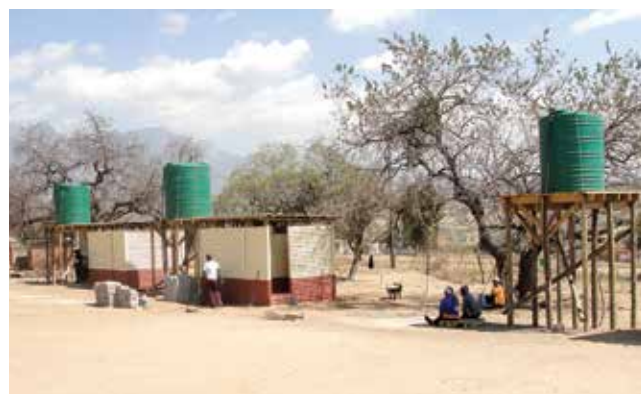
*The WRC is funding a project to construct pour flush toilets at six Limpopo primary and secondary schools. The toilets are housed in timber frame units, with the timber coming from removed alien invasive vegetation.*

Pour-flush or low-flush toilets potentially offer the best of both worlds, bridging the gap between the convenience of flush systems and the sustainability of VIP systems. With a pour-flush toilet, one to three litres of water is poured into the bowl to flush the toilet, pushing the excreta through the water-seal

and into the collection chamber. With a low-flush toilet, a cistern dispenses three litres of water around the pan with each flush. Both types cost significantly less than a full-flush toilet, although about 20% more than a VIP, and greywater can be used for flushing.

With WRC funding, Partners in Development developed a pour-flush prototype in 2010, which was modified into a low-flush system in 2013. Both types terminate in a simple soakaway or leach pit, which is relatively small compared to a septic tank. Ideally, twin pits should be installed, so that when one becomes full the other can be used instead. The full pit is allowed to dry out for two to four years and then emptied, ready to be used again once the operational pit reaches its capacity.
